ERDC/GSL TR-04-5

Strengthening of Concrete Beams with Fasteners and Composite Material Strips—Scaling and Anchorage Issues

July 2004

Final report

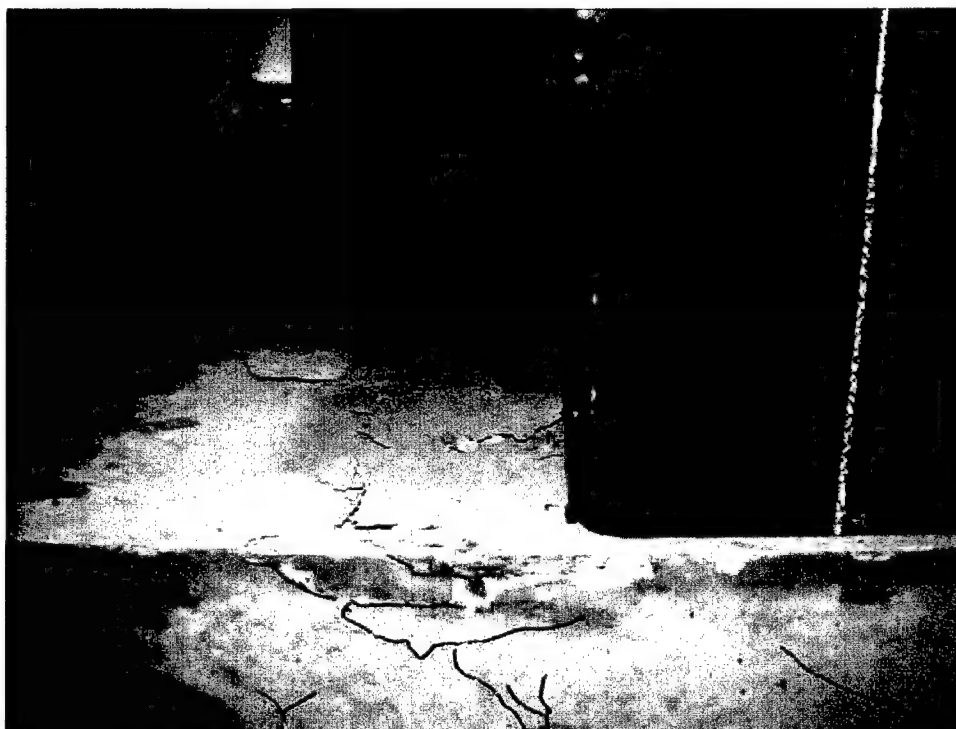
Figure 6. Concrete compression failure for Beam DS 18

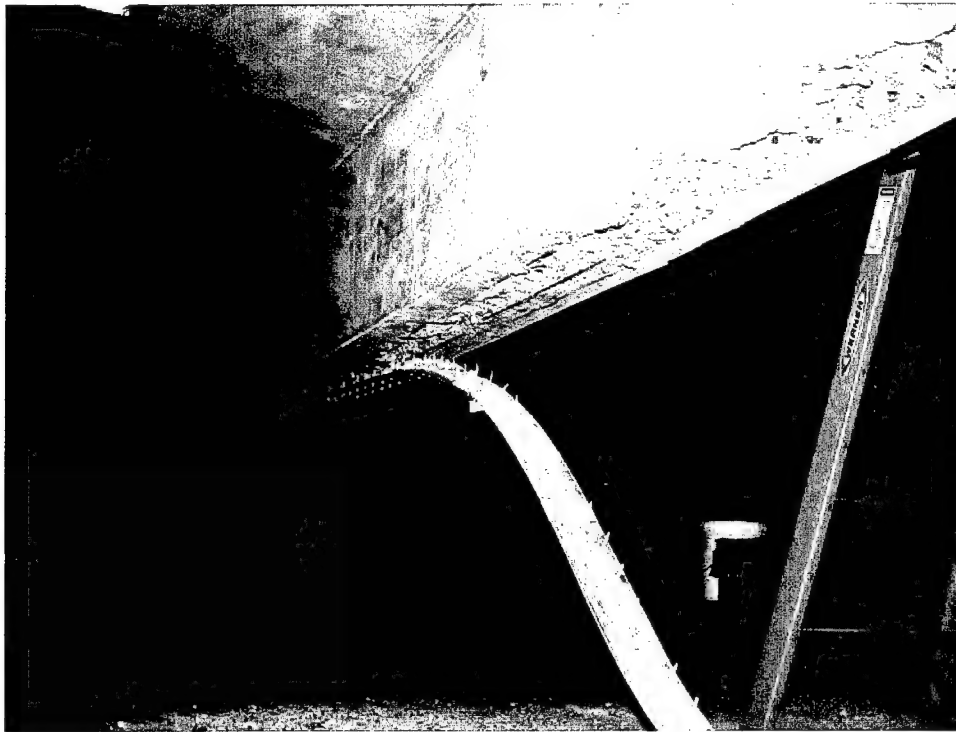
The beam failed by strip detachment initiating at the west end of the beam. The delaminated strip is shown in Figure 8. After the strip detached from the beam, the beam continued to reload. The beam then failed resulting from concrete compression failure, and still continued to carry additional load.

Figure 8. Detached strip from Beam DS 3

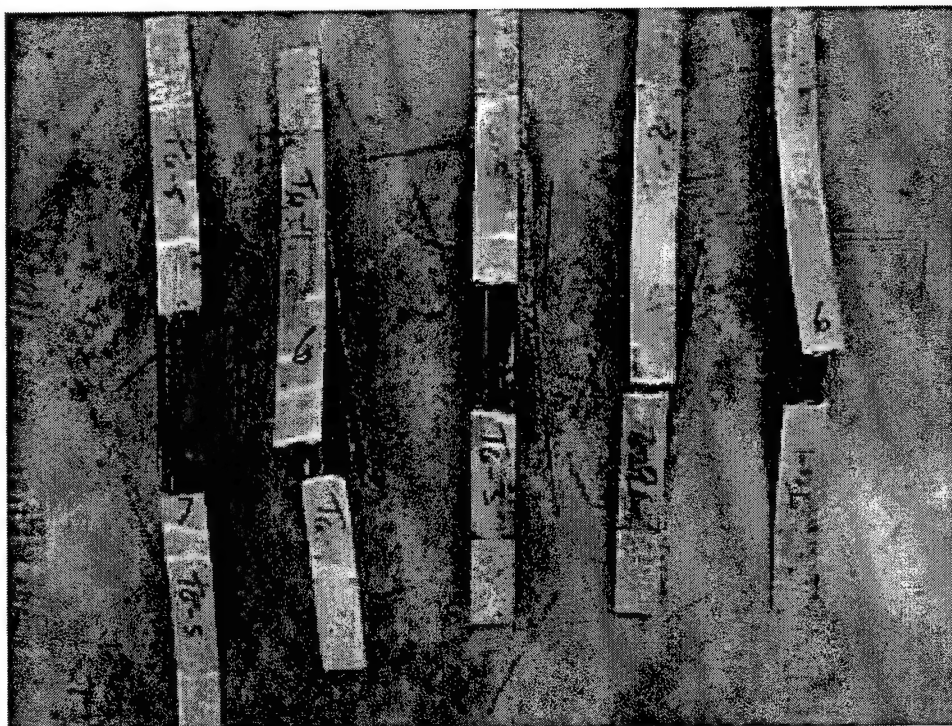
Figure 21. Typical failure mode for tension test specimens

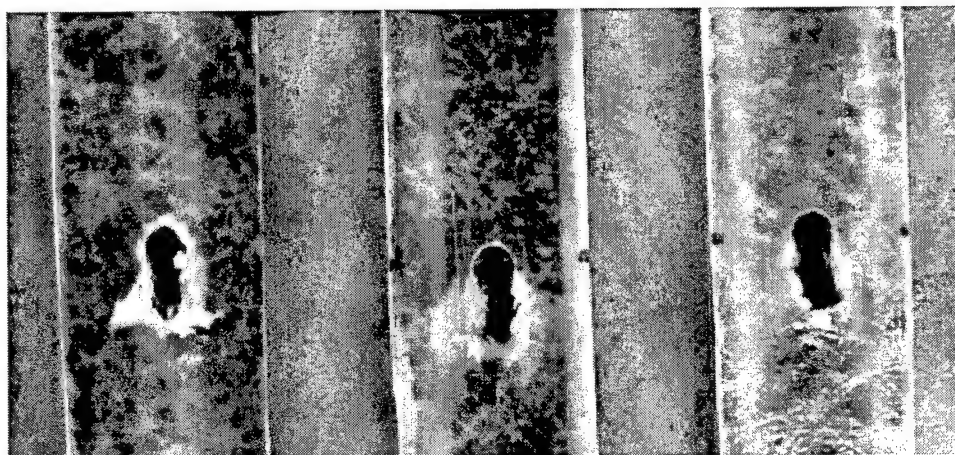
Figure 26. Typical bearing failure mode observed

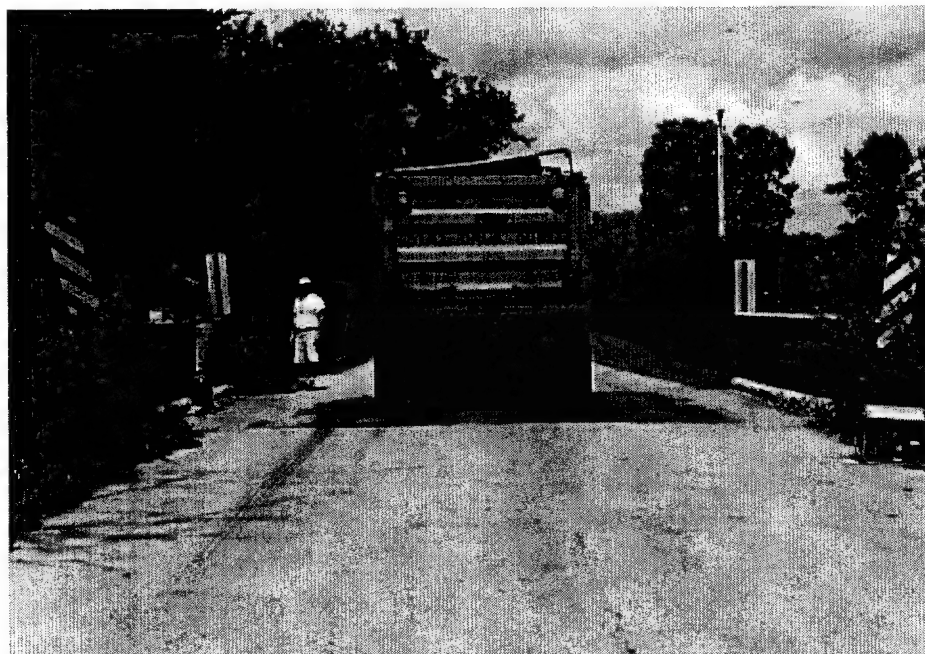
The load cases were considered to represent the most extreme loading conditions possible. Because of the transverse symmetry of the structure, only one lane was tested. Figure 65 shows Load Case I on the bridge after strengthening.

Figure 65. Load Case I on bridge P-53-702
